**MARYLAND HISTORICAL TRUST
DETERMINATION OF ELIGIBILITY FORM**

Property Name: Maple Homestead Inventory Number: F-3-131
Address: 6224 Jefferson Pike (MD 180) Historic district: ☐ yes ☒ X no
City: Frederick Zip Code: 21703 County: Frederick
USGS Quadrangle(s): Frederick
Property Owner: John D. and Naomi K. Zimmerman Tax Account ID Number: 443236
Tax Map Parcel Number(s): 136 Tax Map Number: 76
Project: MD 180 at Greenfield Drive to MD 351 at Corporate Drive Agency: Maryland State Highway Administration
Agency Prepared By: A.D. Marble & Company
Preparer's Name: Emma Young Date Prepared: 7/19/2007
Documentation is presented in: Maryland Inventory of Historic Properties form, F-3-131, on file at the Maryland Historical Trust, Crownsville, Maryland.
Preparer's Eligibility Recommendation: ☒ X Eligibility recommended ☐ Eligibility not recommended
Criteria: ☒ X A ☐ B ☒ X C ☐ D Considerations: ☐ A ☐ B ☐ C ☐ D ☐ E ☐ F ☐ G
Complete if the property is a contributing or non-contributing resource to a NR district/property:

MAPLE HOMESTEAD

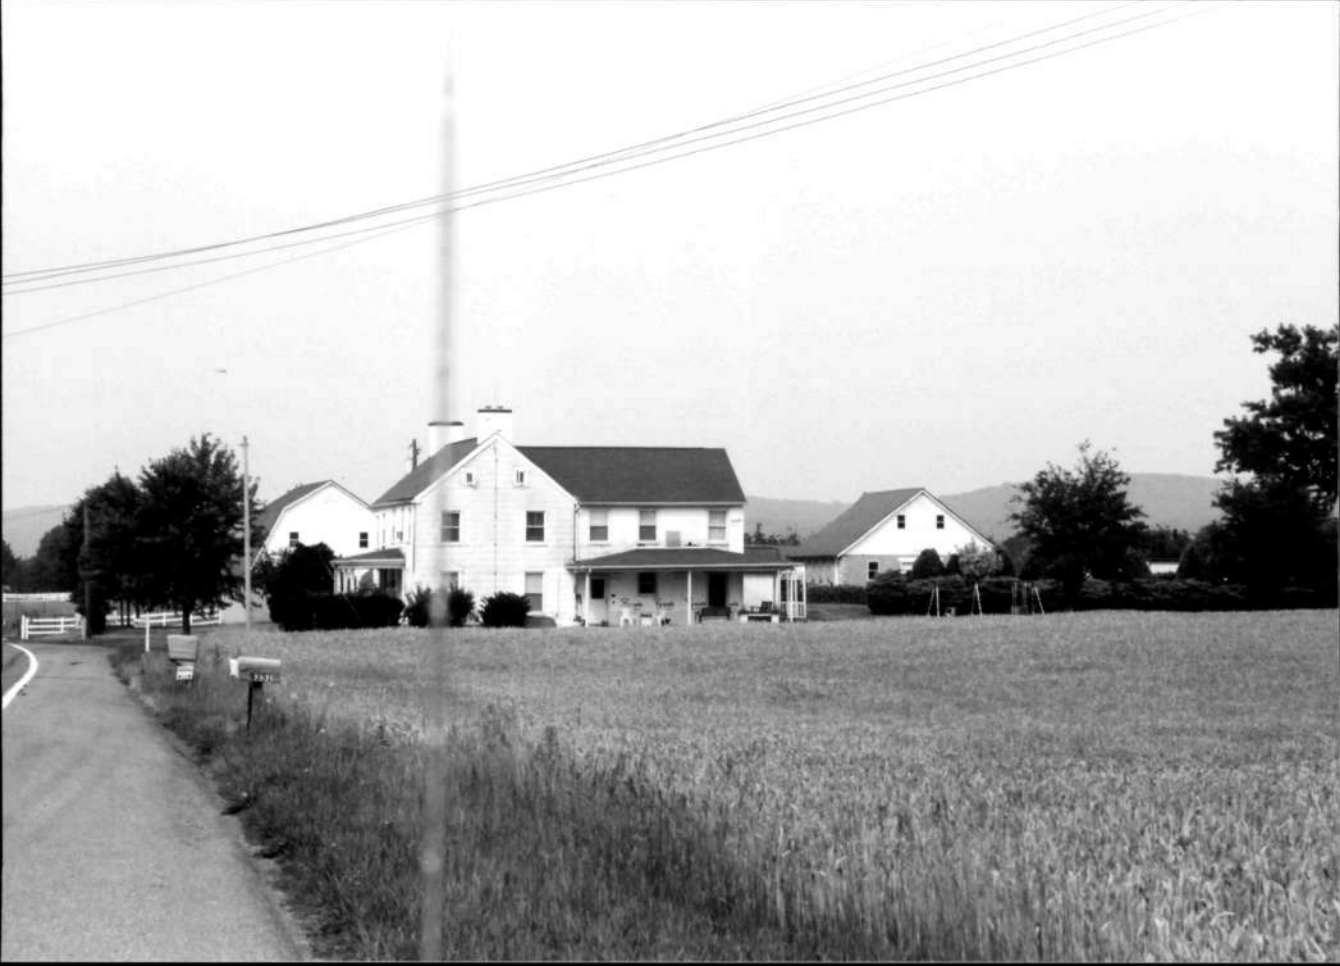
PHOTO # 1 of 9

overview of farm complex, to northwest

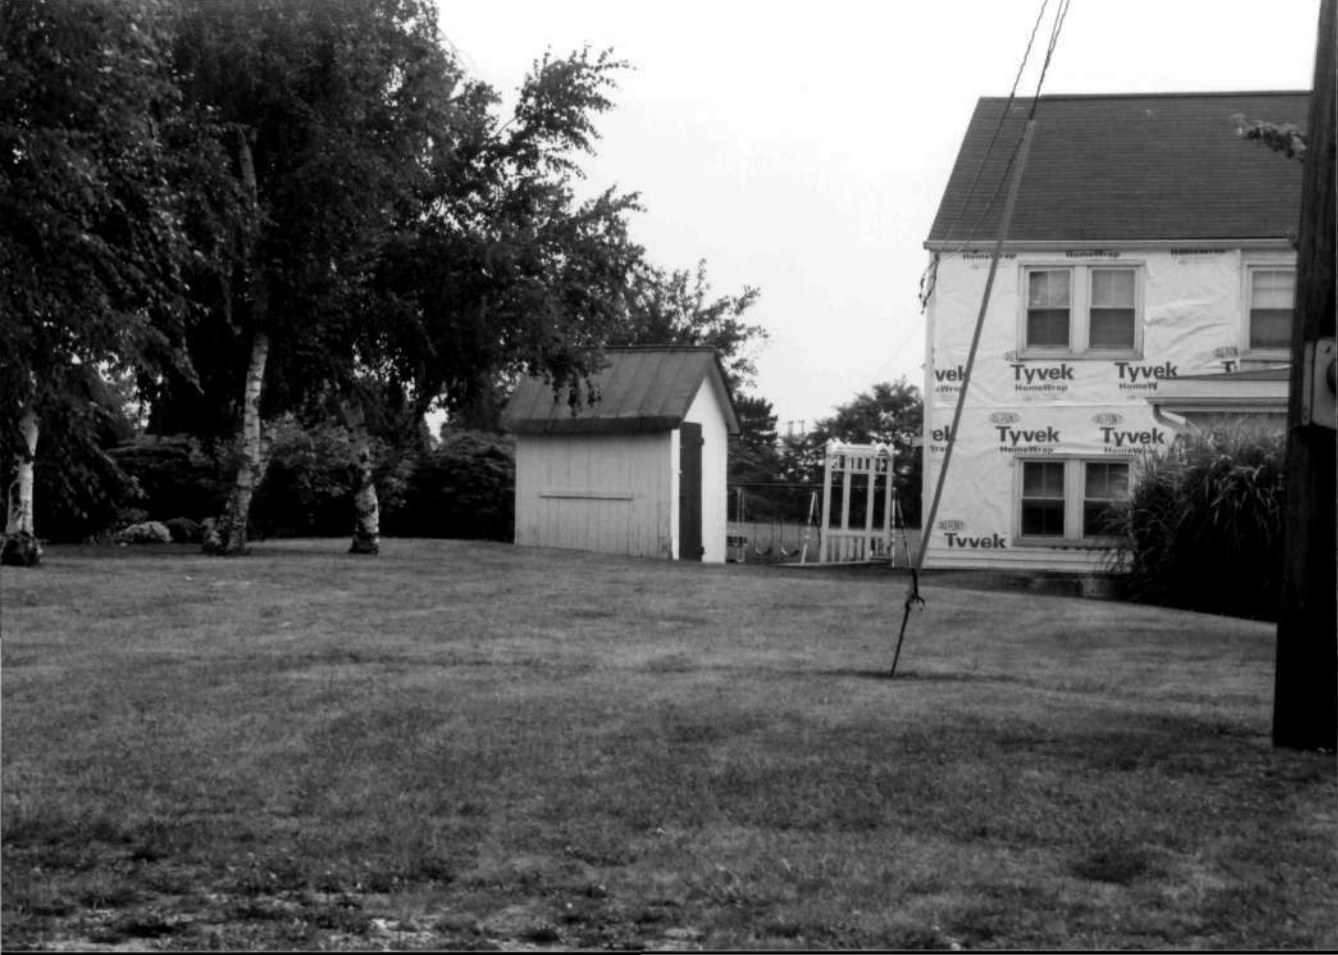
To the northwest of the dwelling is a one-story, frame, circa-1910 smokehouse. Vertical siding, painted white, covers the exterior walls of the building, which is capped by a steeply pitched, front-gable roof, sheathed in standing-seam metal. A single-leaf, tongue-and-groove door, painted green and attached with metal strap hinges, is located in the south elevation of the building and provides the only interior access.

Overall, the building, currently used for storage, is in good condition.

SMOKEHOUSE - SOUTH & WEST ELEVATIONS; VIEW TO NORTHEAST
PHOTO # 4 of 9

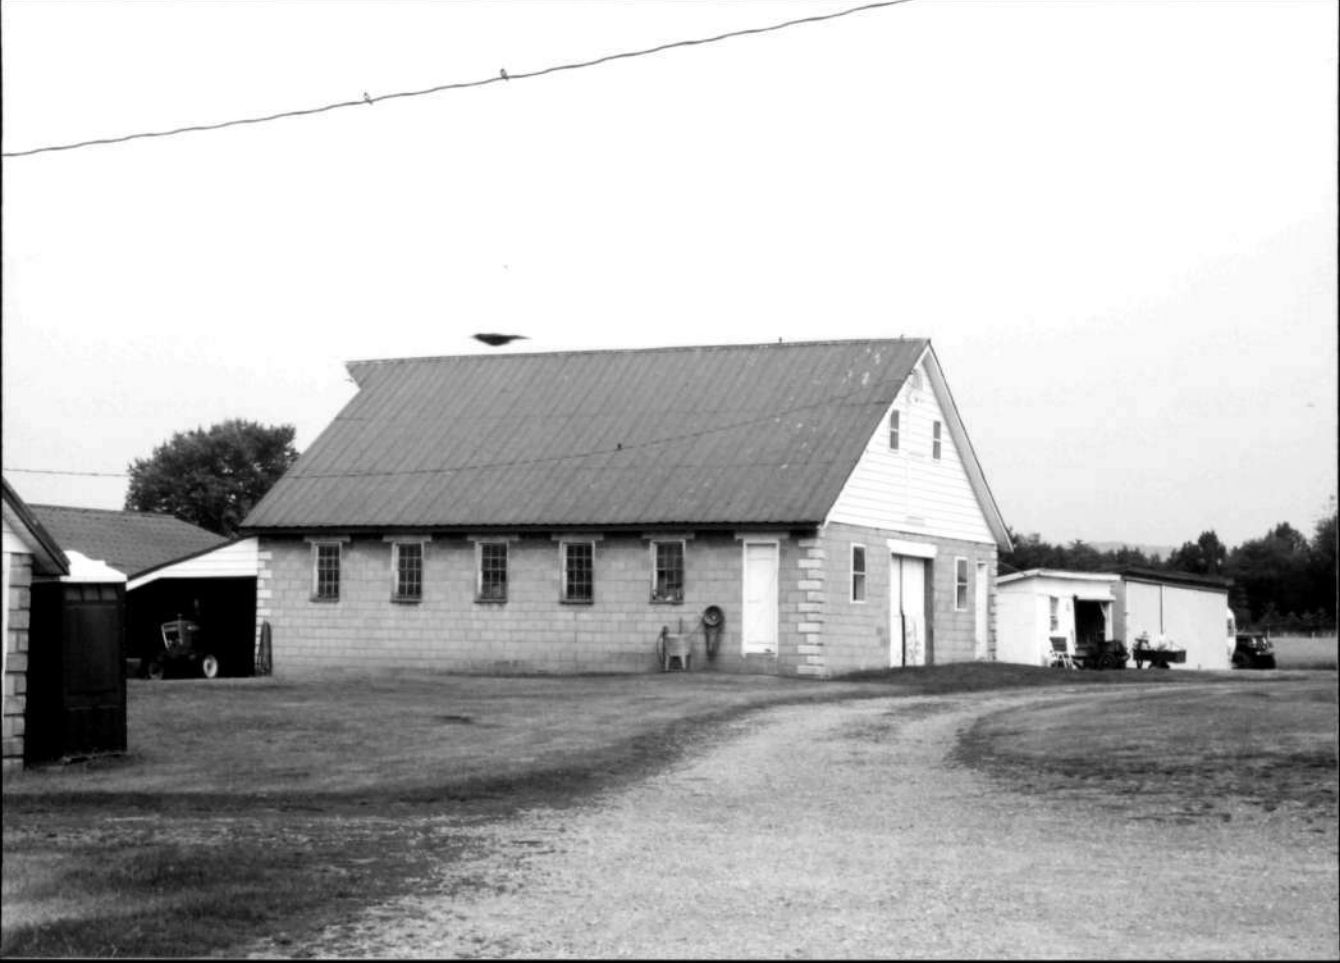
A one-and-one-half-story, concrete-block and frame, gabled hay barn, built in 1942, is located to the north of the stone silo. Concrete block, featuring rusticated quoins, comprises the exterior walls of the building. Aluminum siding covers the gable ends. A steeply pitched, side-gable roof, clad in metal, caps the building and a hay hood projects from the western end.

The hay barn, which retains its original function, is in fair condition.

F-3-131
MAPLE HOMESTEAD
FREDERICK COUNTY, MARYLAND
E. YOUNG
07.2007
MD SHPO
HAY BARN - SOUTH & east elevations; view to northwest
Photo # 7 of 9

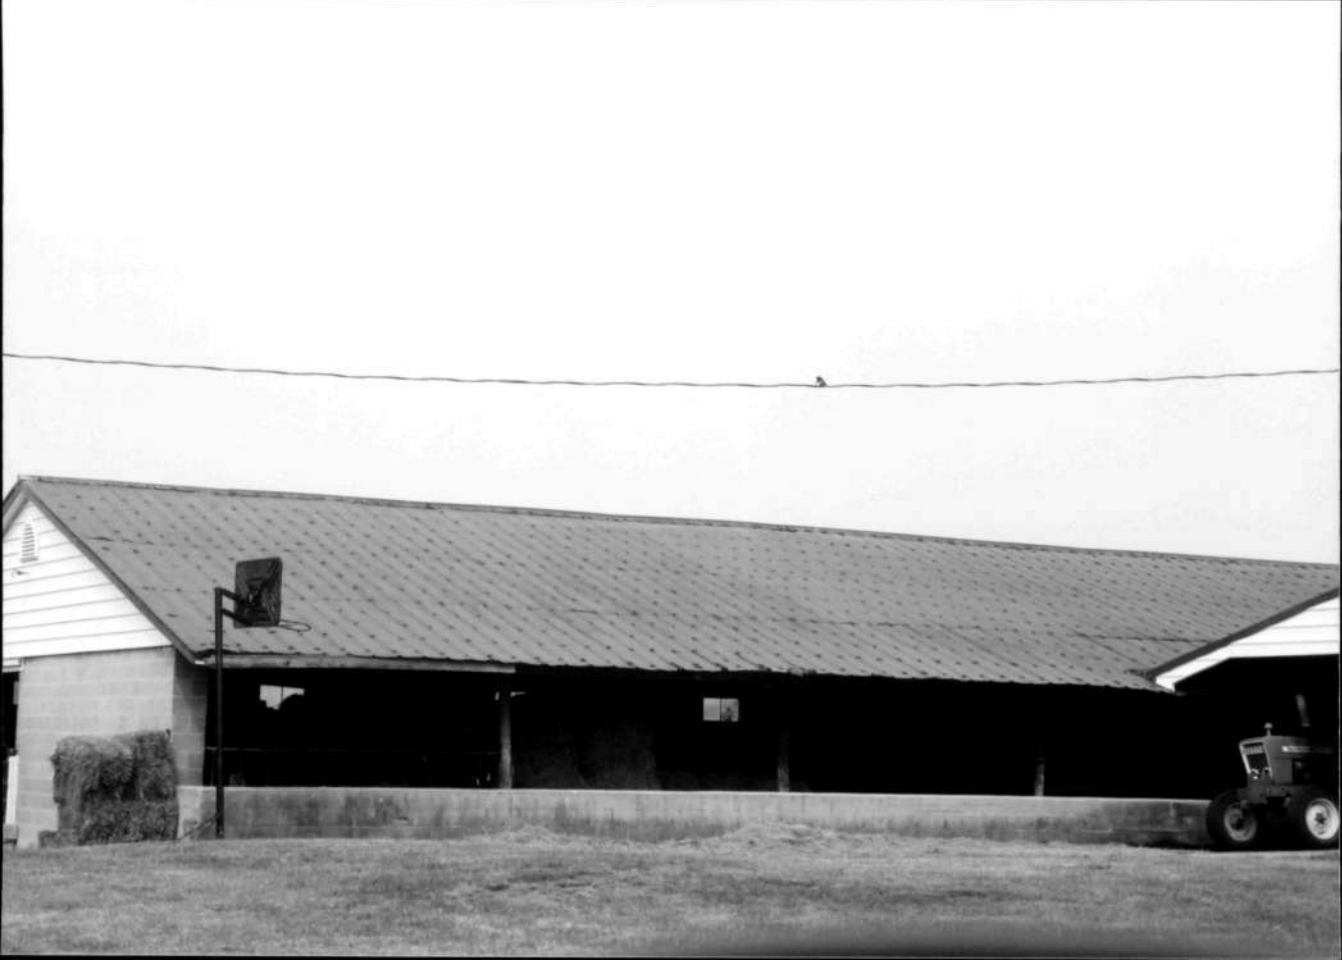
The continued agricultural use of the property necessitated the construction of a circa-1960 loafing shed on the property. The long, rectangular, loafing shed is attached via a shed roof to the west elevation of the hay barn. The loafing shed, comprised of frame and concrete block, lacks the quoins present on the dairy barn, milk house, and hay barn. Therefore, the size and materials of the circa-

1960 loafing shed differentiates it from the historic outbuildings that comprise the dairy farm complex.

F-3-131
MAPLE HOMESTEAD
FREDERICK COUNTY, MARYLAND
E. YOUNG
07. 2007
MD. SHPO
LOAFING SHED (POST-1957) - SOUTH & EAST ELEVATIONS; view
TO NORTHWEST
PHOTO # 9 of 9

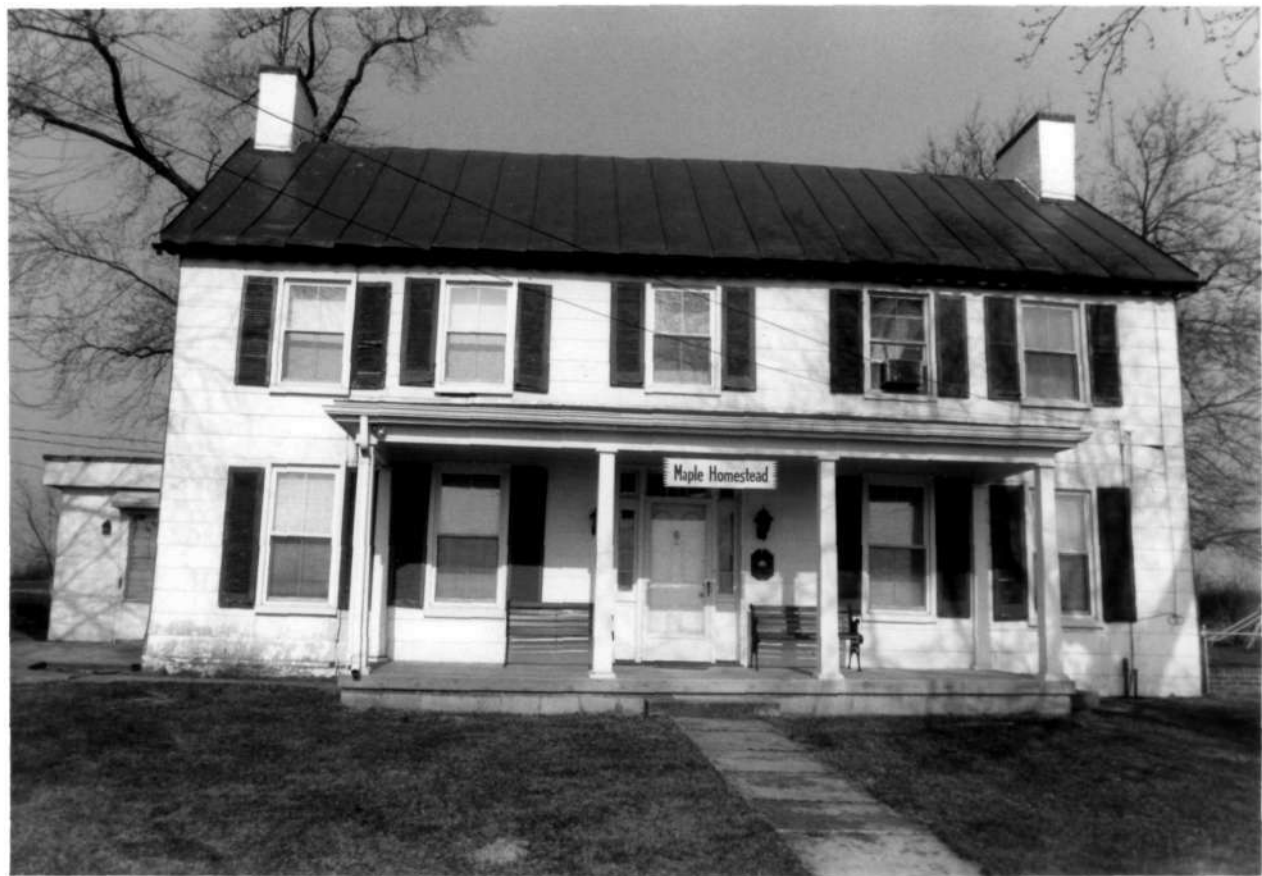
1/9

The dwelling is a two-story structure with five bays facing south toward Jefferson Pike. Its asbestos shingle exterior conceals a stone section on the east and a log section on the west with german siding as an interim layer. A one-story porch over the central three bays was probably added in the late 19th century and altered in the early 20th century. It has square columns, a concrete deck and concrete block base which undoubtedly replaced the original wood platform. The foundation of the house is stone and the windows are 2/2 with louvred shutters. The central entrance has a three-light transom and sidelights. The door has four molding panels with round arches near the top. The original roof was wood shingles and is still in place but covered by a standing seam metal roof installed about 1950. Along the eaves is a serpentine bargeboard decoration. Interior end chimneys rise from the east and west gable ends. A two-story rear wing extends to the north from the northeast corner. The east elevation of the main section has two bays with 2/2 windows and smaller 2/2 attic windows flanking the chimney. On the east side of the rear wing is a modern covered porch. The wing has an interior end chimney on the north gable end and a single 2/2 attic window. On the west side of the rear wing, an originally open porch has been enclosed and extended on the rear of the main section. The interior plan is the central hall with side parlor type, but most floor and wall finishes have been covered with carpeting, wallpaper, or other modern materials. The mantels have been replaced. Because of the log and stone structural materials, however, further observation and documentation of the building's interior is recommended to determine its chronological development.

South elevation

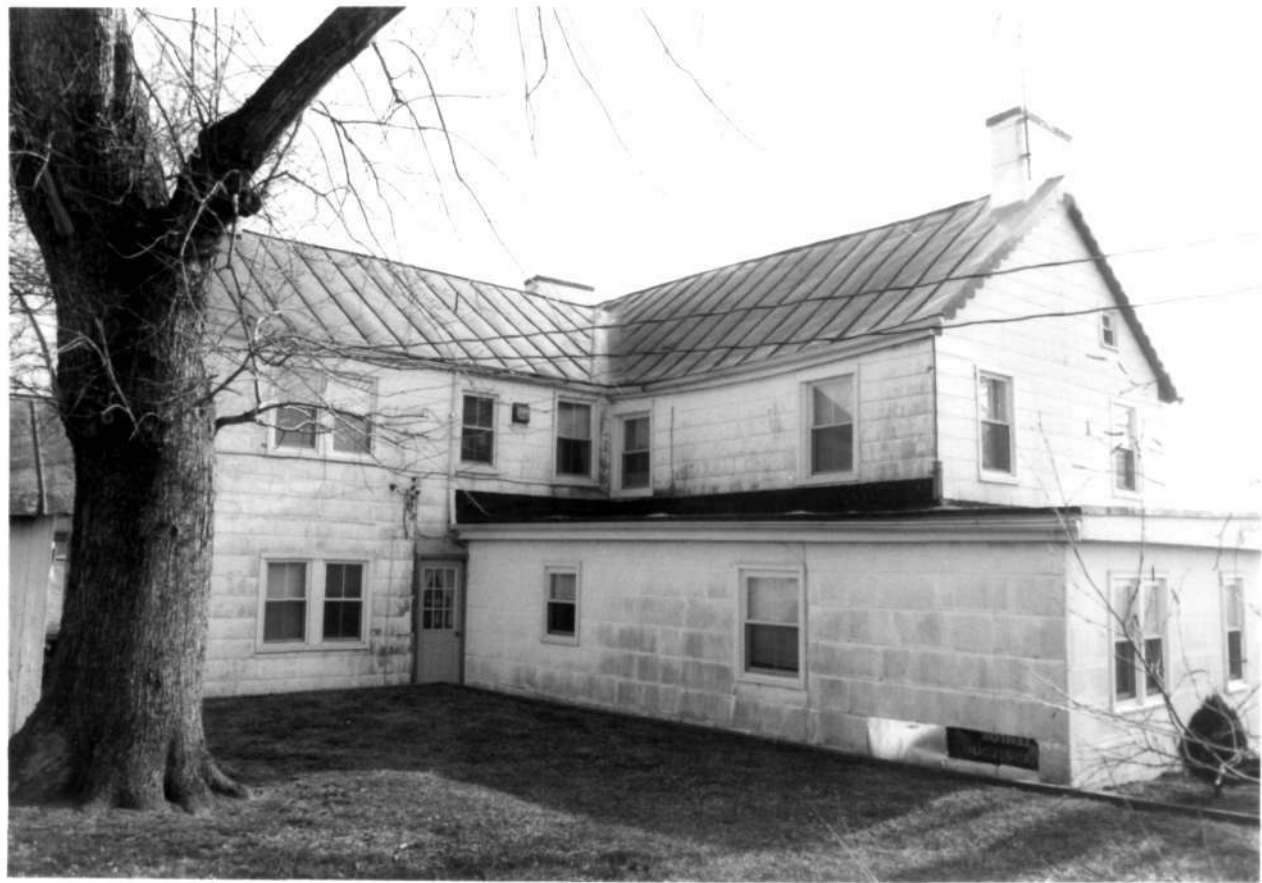
2/9

Northwest corner view

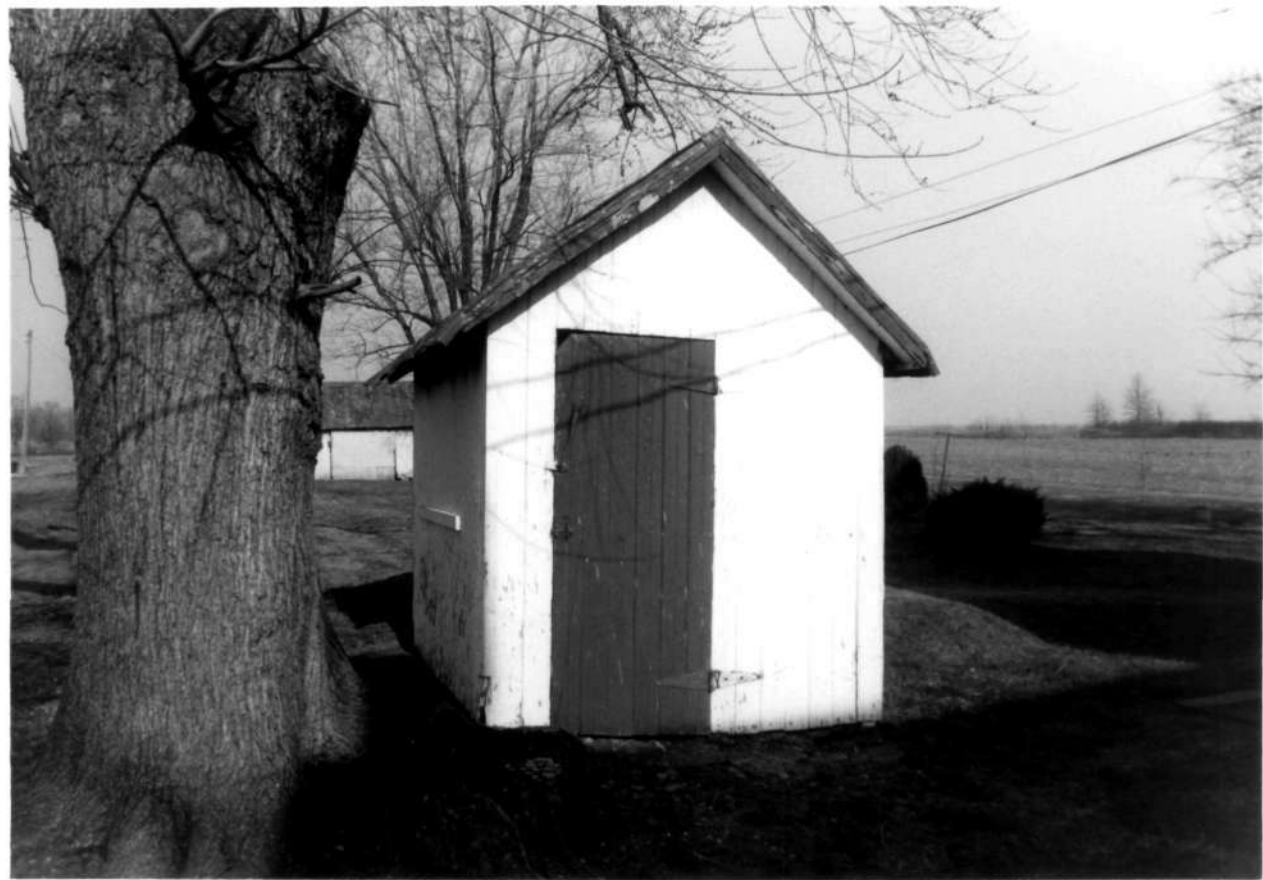
3/9

Smokehouse, south elevation

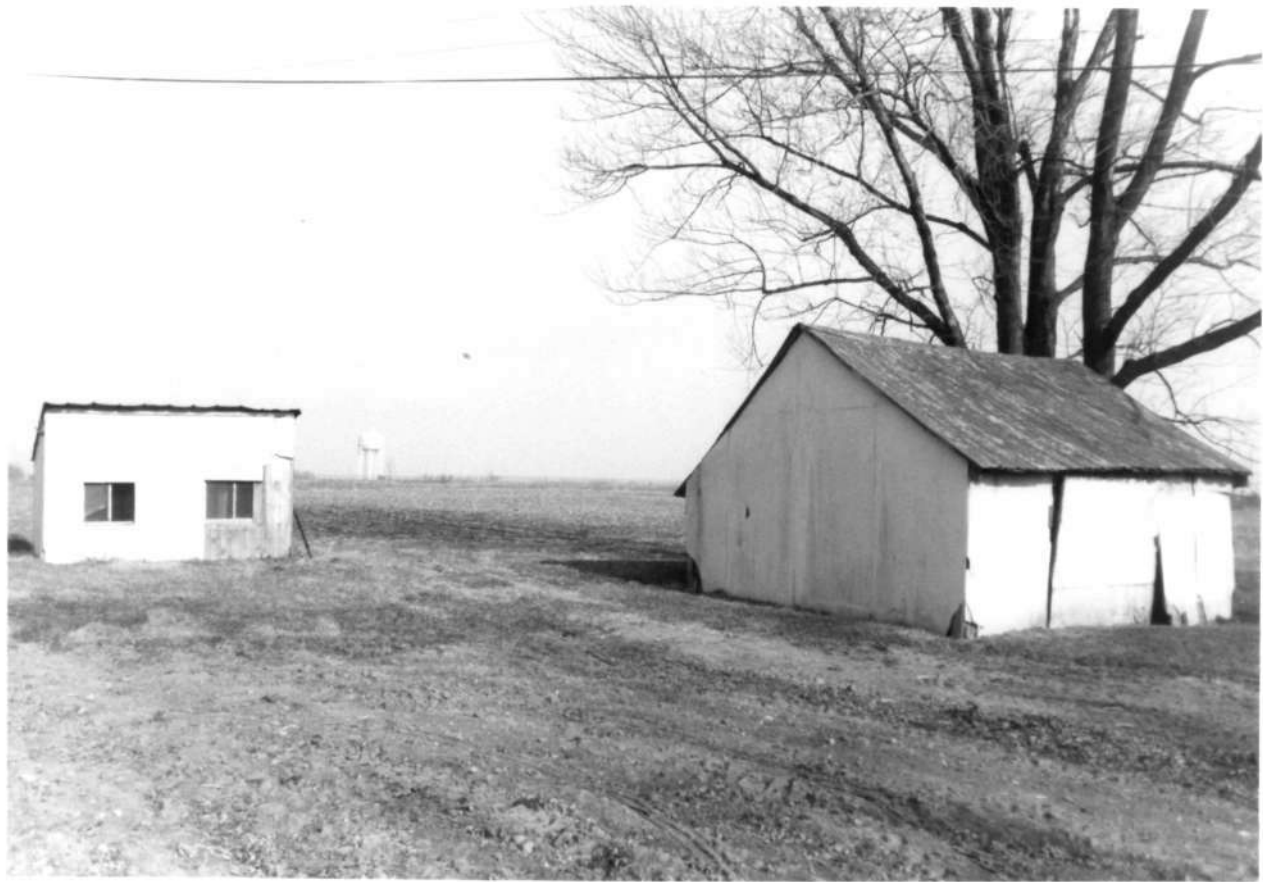
4/9

Blacksmith shop: The former blacksmith shop is located about 25 yards north of the house and is currently in deteriorated condition, with its exterior covered with masonite panels over german siding. Its interior was not accessible to the surveyor; however, Mr. Zimmerman stated the structure was partially frame with some hand-hewn timbers. The blacksmithing tools have been sold, but the forge is still in place. The gable roof is covered with standing seam metal. Its date is probably in the last quarter of the 19th century.

Chicken house and blacksmith shop, south elevations

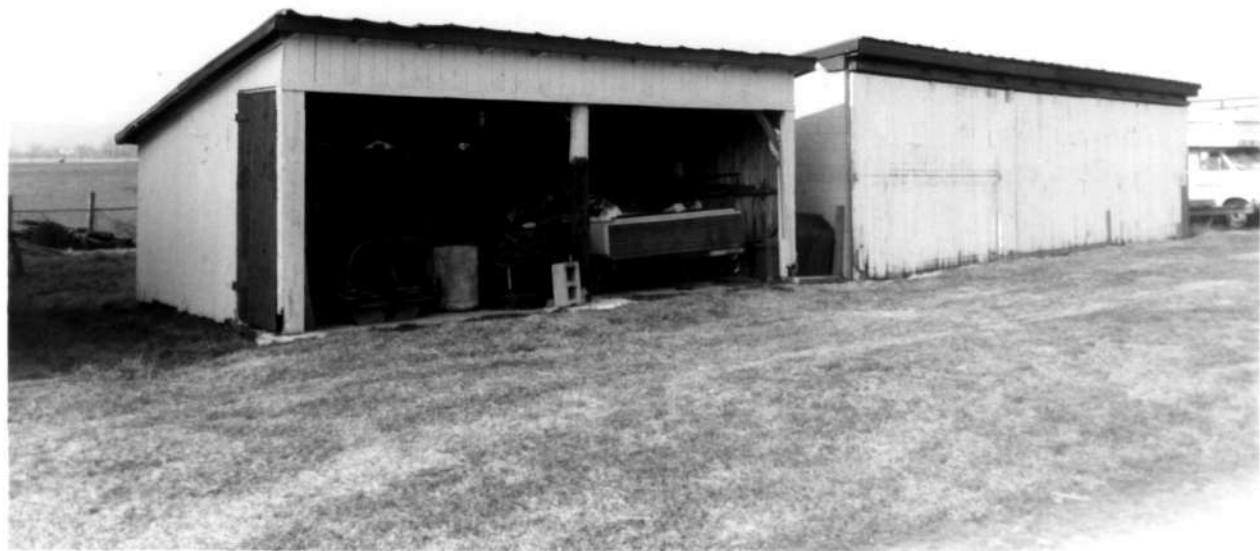
5/9

Machine sheds, southeast corner view

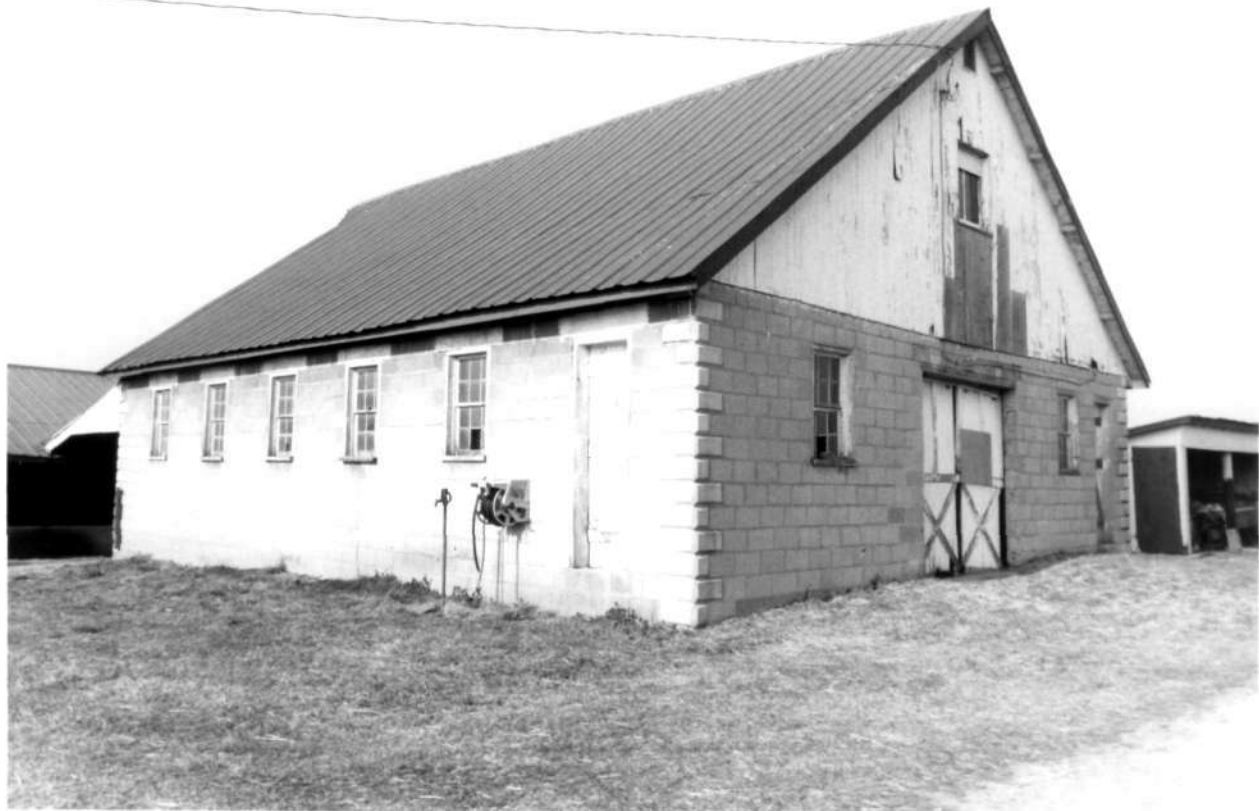
6/9

Hay barn, southeast corner view

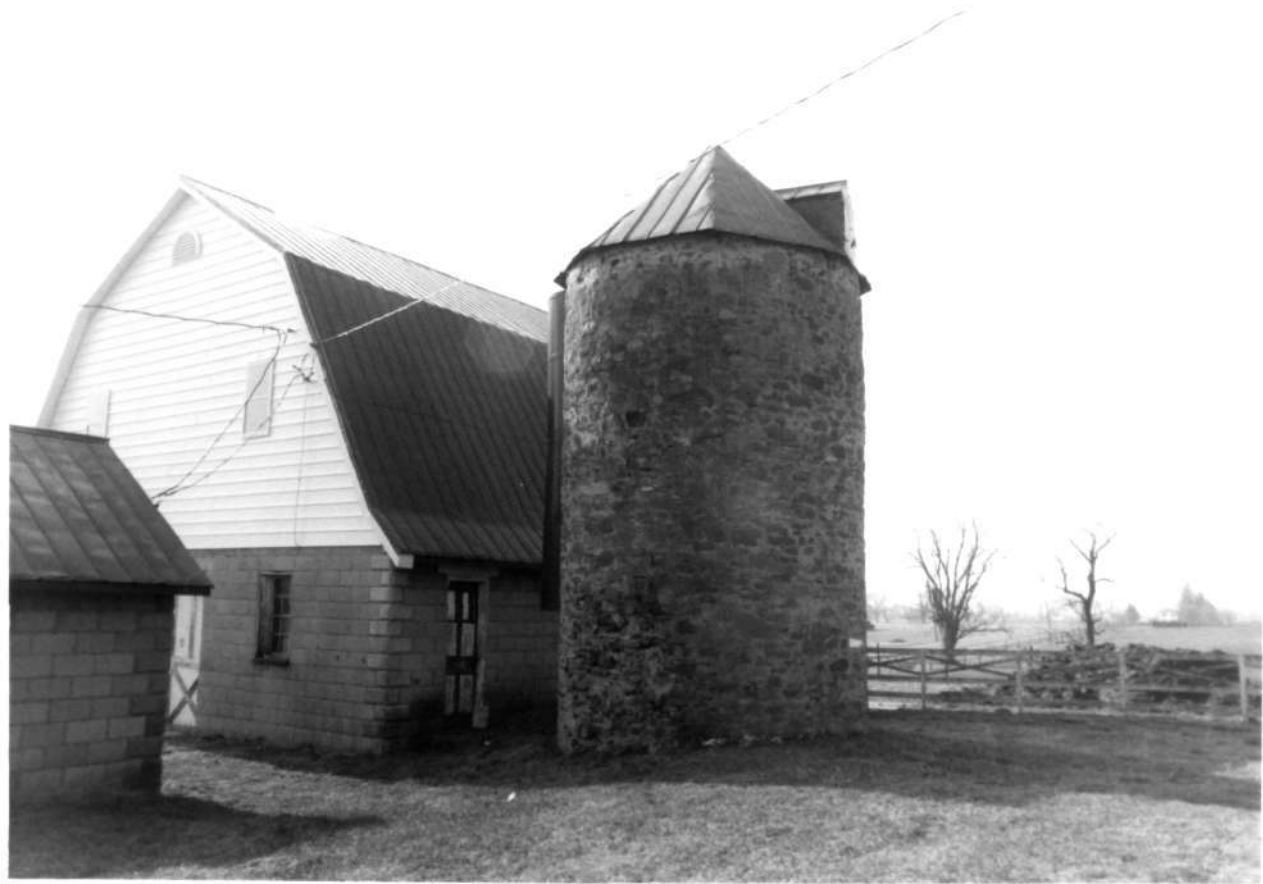
7/9

circa-1920, stone silo is partially banked into a hill, which slopes downward from north to south, approximately six feet to the northeast of the dairy barn. The stone silo is likely built of fieldstone found on the property and also contains various fragments of brick. The silo stands approximately 50 feet tall and measures approximately 15 feet in diameter. A frame conical roof, clad in metal, caps the structure. A dormer access is located on the north side and a metal shoot extends downward on the south side.

Overall, the structure, which retains its original function, is in good condition.

Stone silo, view from north

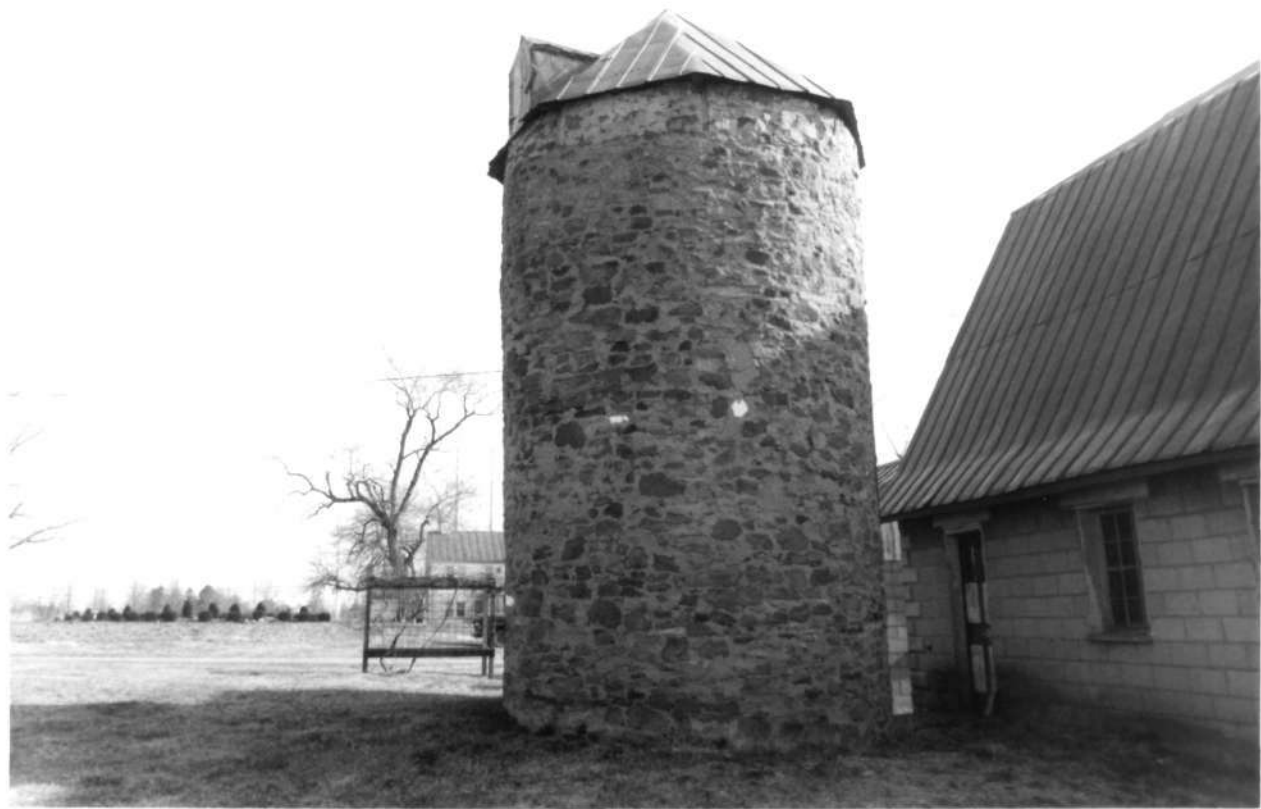
8/9

Stone Silo, view from west
